Manhole Inspection Summary

Manhole # S47K__040MH

Insp Date: **9/22/08 1:49 PM**

Location Address: **side 2200 essex st**

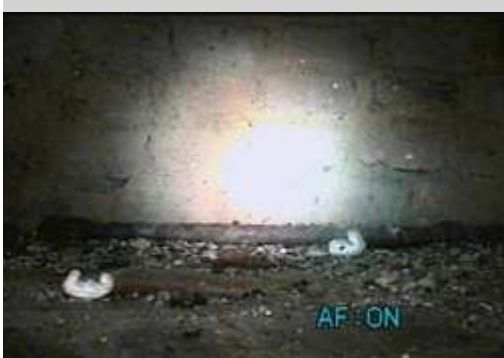
Misc

bench debris

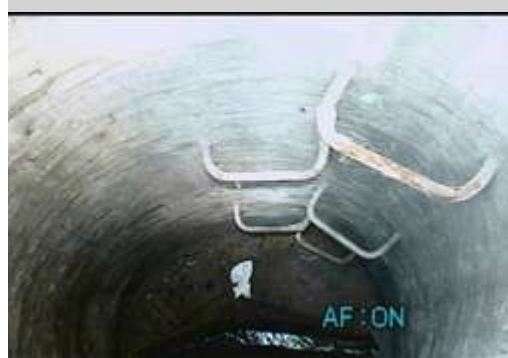
Defect 2

Steps Count: **6** Missing: **0** ☒ **Corroded**

corr steps

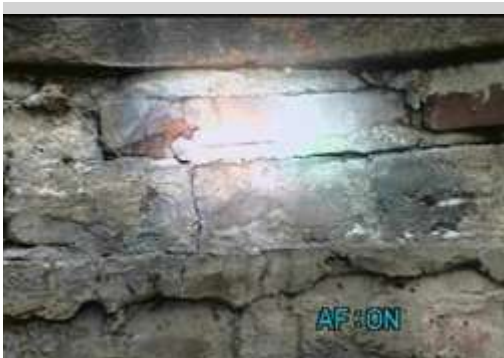
Defect 1

Condition: ☐ Sound ☒ **Cracked** ☐ Root Intrusion ☒ **Loose Brick** ☒ **Deteriorated**

chimney cracked, deteriorated, & loose bricks

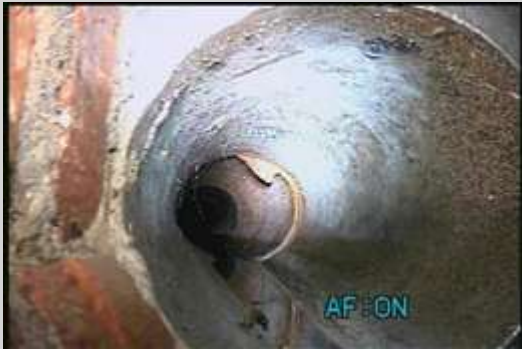
12 O'Clock Outflow

8 in. Circular Gravity Sewer
Pipe Out @ 12 O'Clock

Pipe Material: **Clay** ☐ Pipe Lined

Invert Depth: **10.90** (ft.) Flow Characteristics: **Fast**

Infiltration: **None** Pipe Seal Cond: **Unknown**

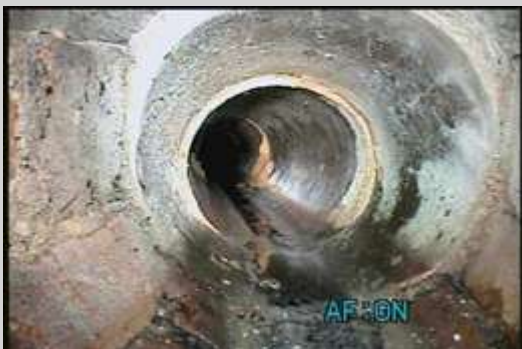
7 O'Clock Inflow

8 in. Circular Gravity Sewer
Pipe In @ 7 O'Clock

Pipe Material: **Clay** ☐ Pipe Lined

Invert Depth: **10.60** (ft.) Flow Characteristics: **Fast**

Infiltration: **None** Pipe Seal Cond: **Unknown**
